**REPAIR TECHNIQUES AND REMEDIES FOR STRUCTURAL FLAWS
FAILURE IN JUIT**

Project Report submitted in partial fulfillment of the requirement for the degree of

Civil Engineering

DEFECT IN REPAIR WORK ON THE ROOF OF ECE DEPARTMENT

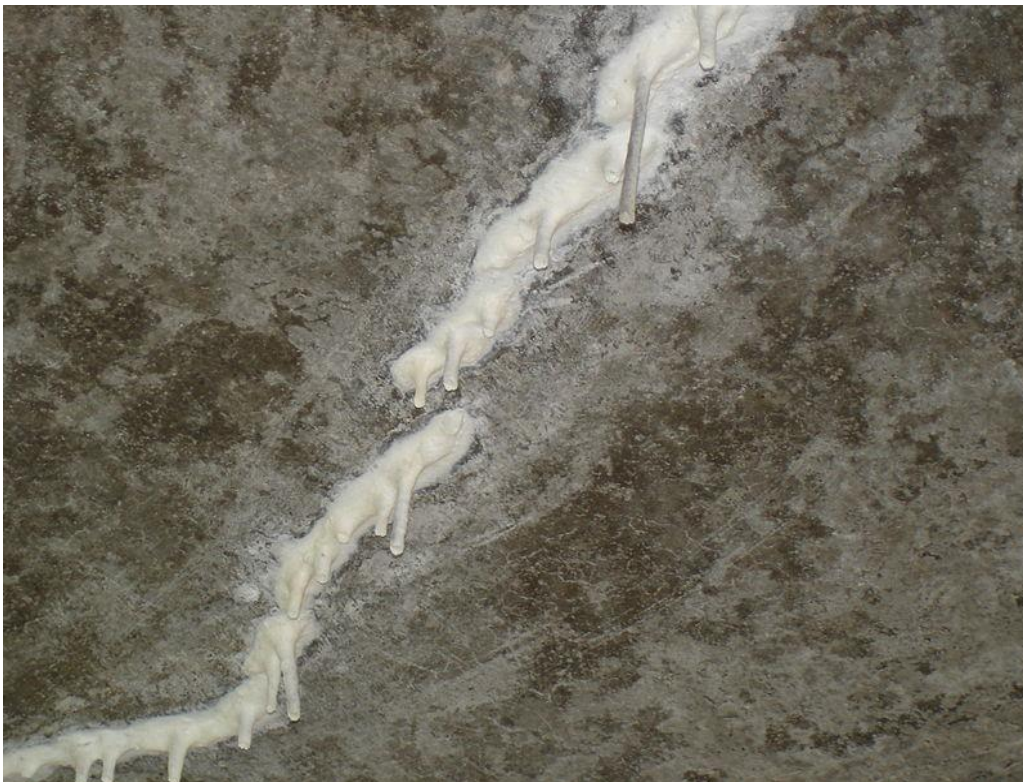
Fig 1 white scales with water percolating from it on the roof of ECE department

1. The color of the cement mortar used after the replacement of the choked conduit pipes was different from the original slab. On talking with Mr. Dinesh Kumar, junior engineer of the maintenance department of the JUIT he said that the water resistant material was used in the cement water to stop the leakage of water.

2. The formation of this whitish material was due to calcium carbonate efflorescence. A few of the lecturers cabin were made unusable because of the continuous leakage of water from the roof. He even concluded that the choked conduit pipes could not be replaced as the conduit pipes were placed inside reinforcement bars and for replacing it they would have to cut the reinforcement bars which would lead to dismantling the entire slab.

3. Water was leaking from the slab because the above the department is a terrace which had no outlet for rain water that might collect and even the conduit pipes were placed inside the slab, so it could even be due to leakage of water from the conduit pipes. Even after using water resistant material in the cement mortar, water was leaking from the conduit pipes and white scales were formed on the surface of the concrete. This was due to Efflorescence. The white scaling rose on the surface due to presence of some water soluble salts in water, cement, sand, lime or clay, if used. Even rain water carry dissolved sulphates from the air which may percolate into concrete or plaster. These salts get dissolved in moisture present in mass of concrete, plaster or masonry. The water serves as carrying agent for the salt to bring them to the surface of concrete. At the surface of concrete, the water evaporates into air but salt cannot vaporize under normal

The necessary solutions or repair technique as suggested for patch repair is crack sealing and restoring the lost concrete cover. If due to corrosion any reinforcement has been effected. Carbonation resistant protective coating should be used. However further tests and researches should be carried out in order to determine the actual remedies and repair technique.

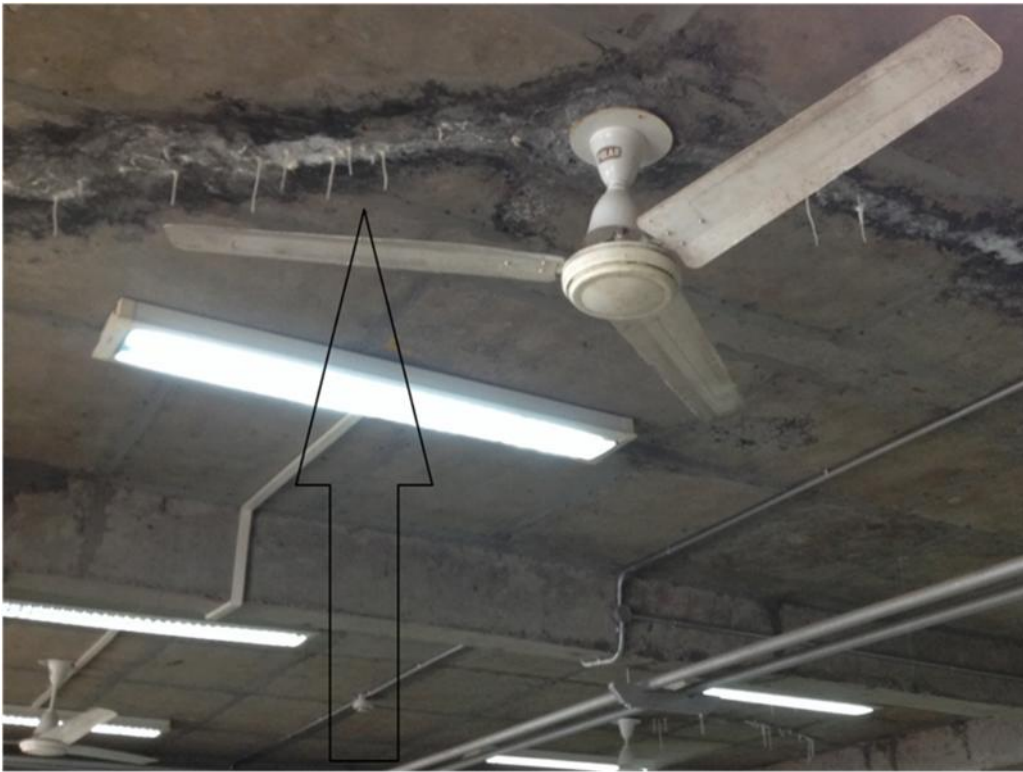
Fig 1.2 Picture survey of the ECE department.

1. The color of the cement mortar used after replacement of the choked conduit pipes was different than the original color of the slab.
2. Formation of white unappealing scales was observed on the surface of the slab.
3. Water was leaking from the surface of the white scales which were hollow from inside, appearing like a pipe.

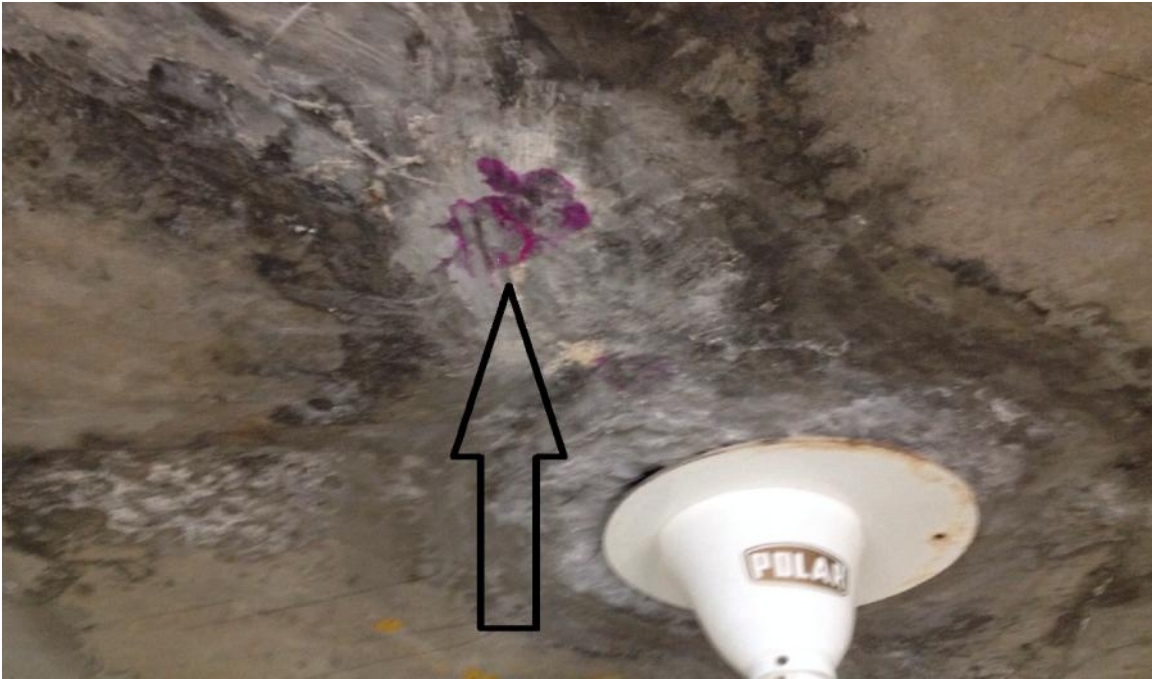
Figure 1.5 Carbonation Test

From Fig. 1.6 it can be seen that after spraying of phenolphthalein indicator in cracks and in drilled hole, appearance of pink color is observed. It shows the concrete is not affected by carbonation.

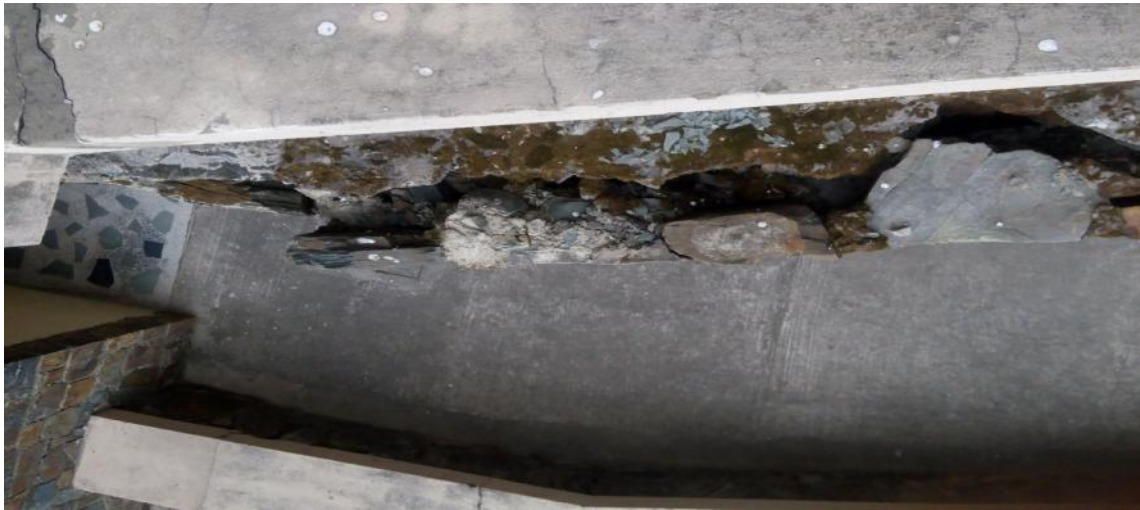
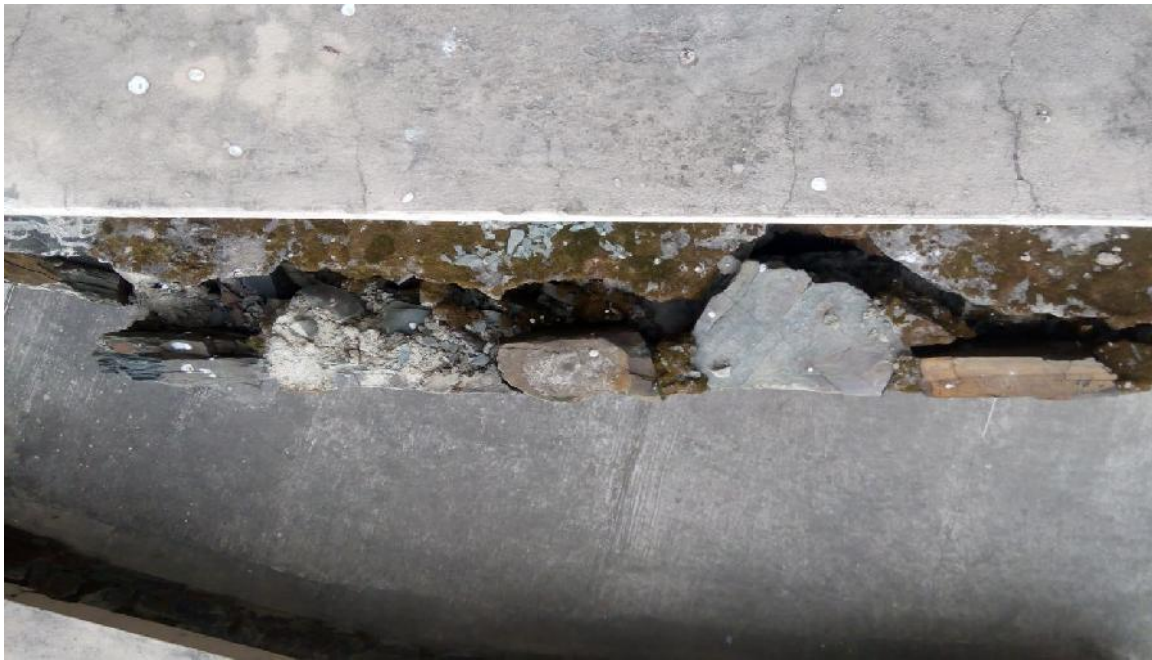
5. Even though the cracks were big there was no sign of exposed reinforcement in the case of cover of the shear wall because the cover was just the masonry and it reinforcement was held within the shear wall. But in the case of the column it is unknown whether the cracks extend throughout the column or it was just the masonry cover, it is so because it was invisible from the cracks .

Fig 2.1 and 2.2 Top view of the cracks in shear wall

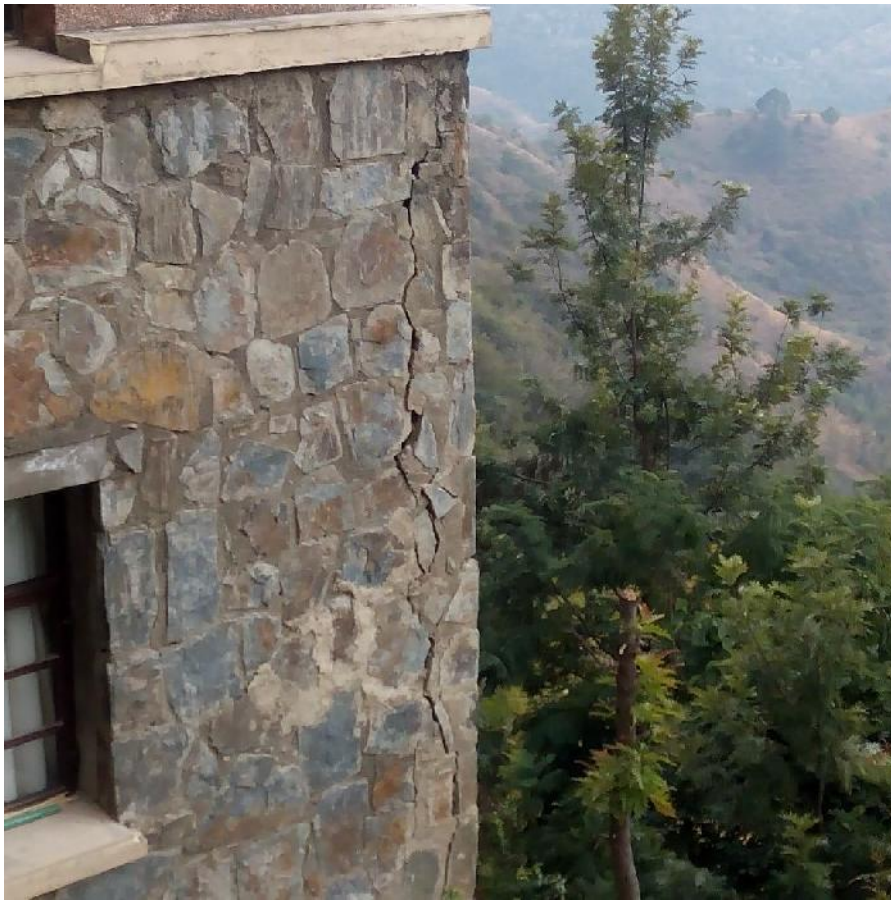
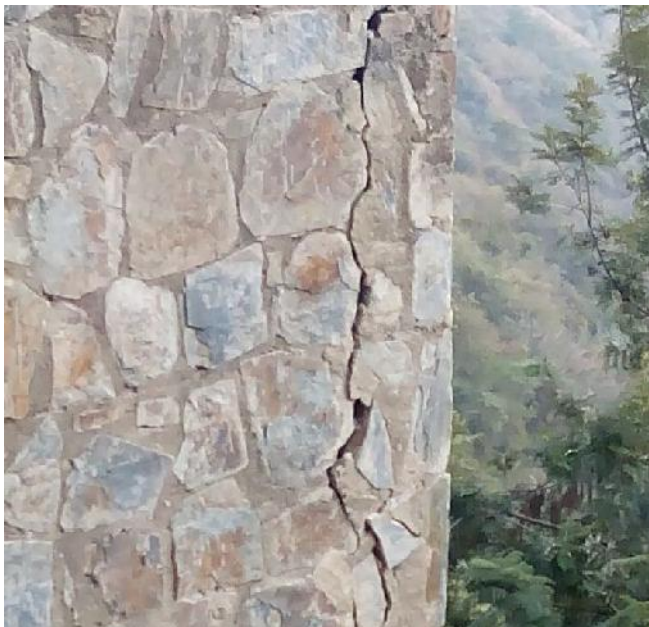
Fig 2.3 and 2.4 Cracks in the column of C4 block.

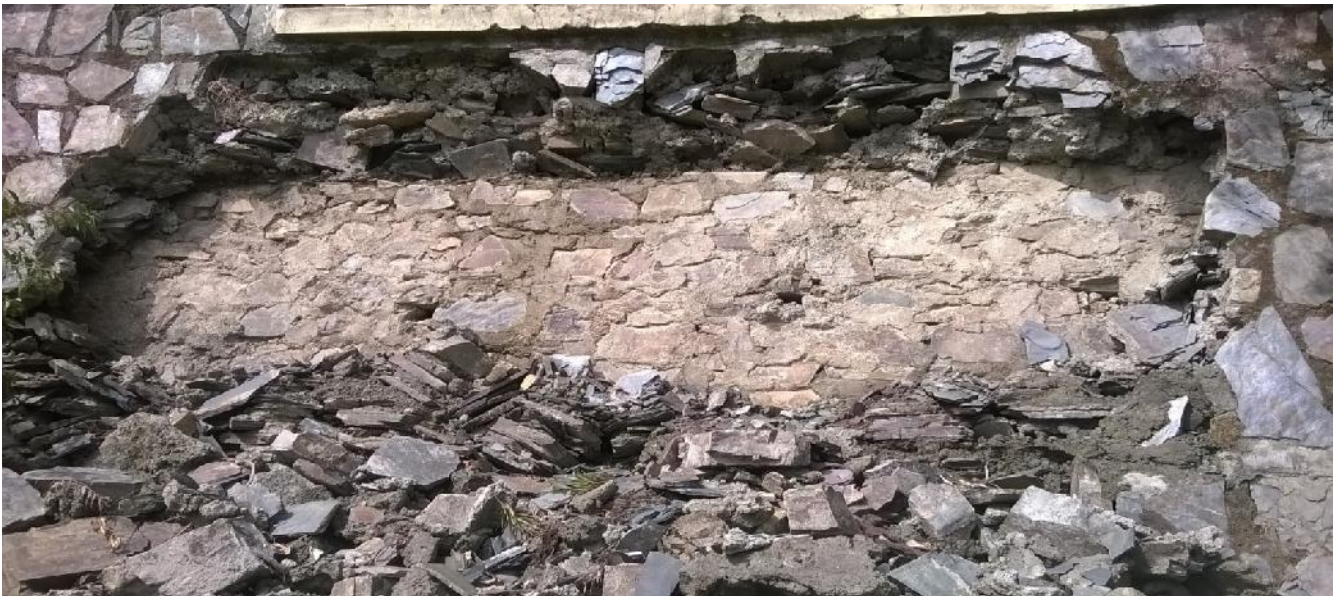
Due to heavy rainfall in the month of February and March this problem occurred. Such kinds of problem are common here in JUIT because all the concrete structures here have masonry covers which due to alternate wetting and drying conditions loses its bond strength with the cement paste in between them. During the examination it was found that the all the weep lines are clogged and no maintenance was carried out to clear the weep lines. Weep lines were clogged during the previous rainfalls.

Fig 3.1 front view of the delaminated wall

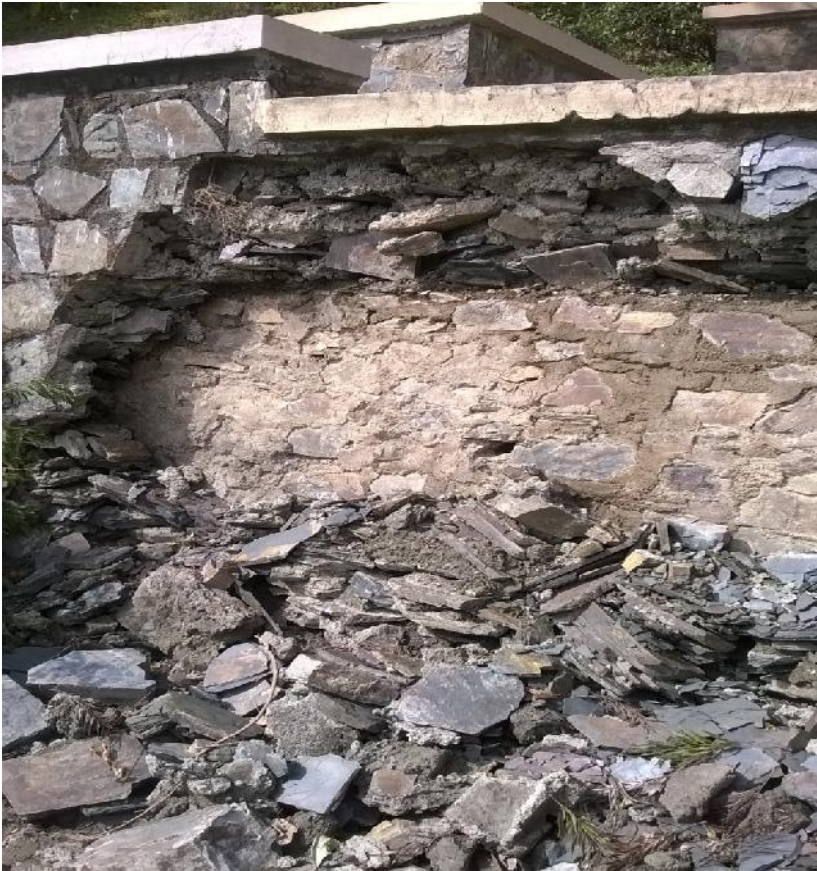
Fig 3.2 Delaminated wall near the play ground

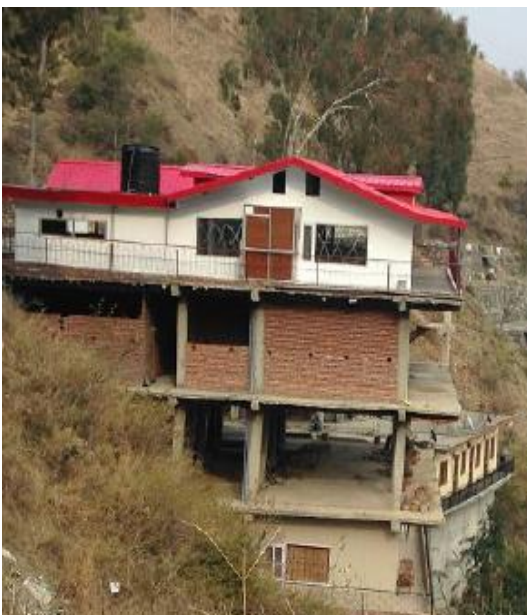
A soft storey is one in which the lateral stiffness is less than 70% of that in the storey immediately above, or less than 80% of the combined stiffness of the three stories above. The essential characteristic of a weak storey consists of a discontinuity of stiffness, which occurs at the second storey connections. This is caused by lesser strength or increased flexibility and also the structure results in excessive deformations in the first storey of the structure, which in turn results in concentration of forces at the second storey level. These stories are more likely to get collapsed or were severely damaged during earthquake. Many buildings with an open ground storey (soft storey) were observed in Kandaghat. Fig. 3.4.2 shows a residential house being constructed and the ground and first floor are left empty whereas a house is dwelled in second storey. Fig. 3 and Fig. 4 are also good examples of soft storey. This defect can be minimized by constructing shear walls at the ground level so as to eliminate the discontinuity in the lateral load resistance path and to increase stiffness of soft storey .making it comparable with other.

Fig 3.6 Soft storey of a hotel in Waknaghat
