Landslide Analysis & A Case Study on Recent Landslides in Solan, Shamti

Major Project Report

CIVIL ENGINEERING

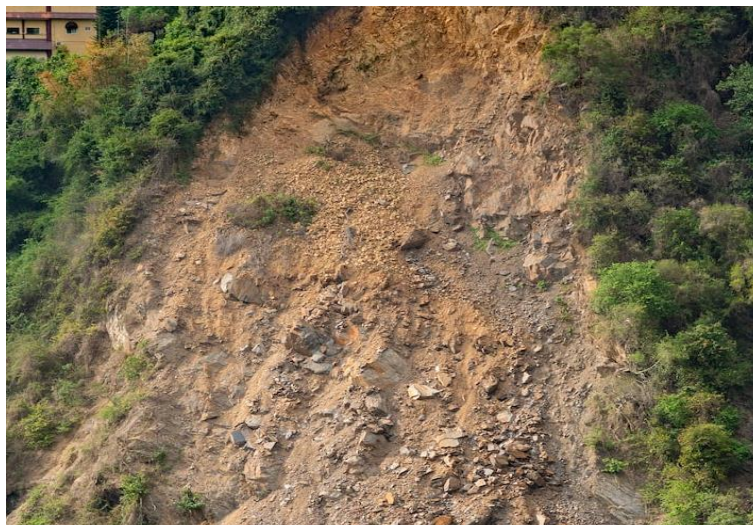
With minimal rotating movement or tilting backward, the mass in a translational landslide flows outward, or down and outward, down a comparatively flat surface. Rotational slides tend to return the slide equilibrium; however this kind of slide can go significant distances if the surface of rupture is steep enough. There might be large slabs of rock, loose, unconsolidated soils, or both in the slide. Along tectonic discontinuities like faults, joints, bedding surfaces, or the interface between rock and soil, translational slides frequently collapse. In areas with permafrost, the slide may also go down it.

Fig- 1.3 Translational Landslide

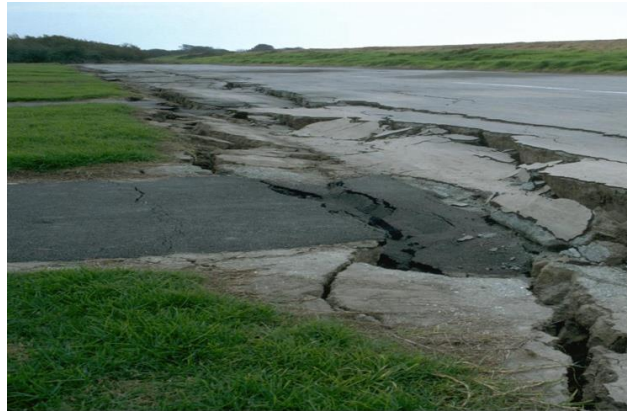
An expansion of cohesive rock or soil mass together with a general collapse of the cohesive material's fragmented bulk into softer subsurface material. The softer underlying material may liquefy or flow (and extrude), causing spreads. Block spreads, liquefaction spreads, and lateral spreads are examples of spread types.

Fig – 1.4 Spreads

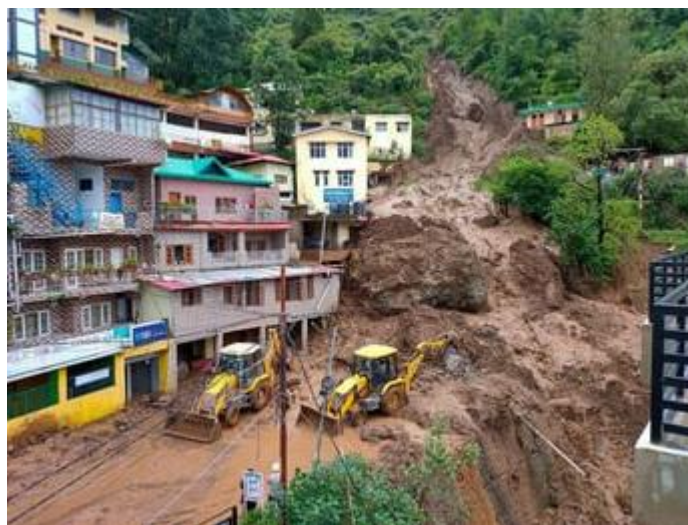
Rainfall cause landslides in Himachal Pradesh through a process known as **saturation**. When intense or prolonged rain occurs, the water infiltrates the soil, increasing its weight and reducing its strength. This can lead to a **loss of friction** between soil particles, making slopes unstable. In Himachal Pradesh, which has steep terrain and fragile geological structures, this process is particularly dangerous.

Fig-1.9 Rainfall Causing Landslide

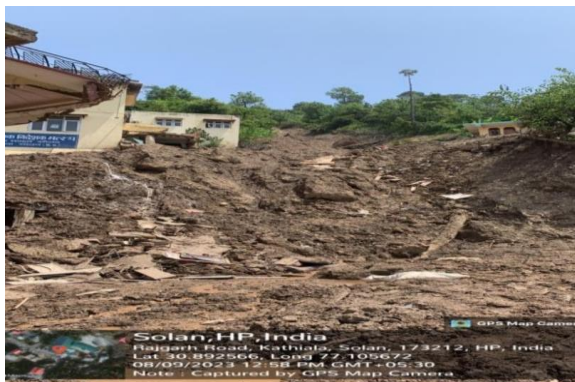
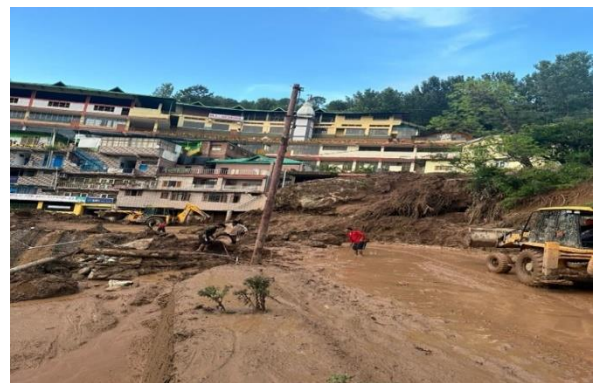
The fisheries office was located between a temple and a school from 2007 ,and also there was a flowing water channel which started from the hills, it flows down from behind the school and lastly it flows down to the road from between the temple and the fisheries, as this location is in step wise formation which was one of the basic reason of complete drowning of the Office in debris flow Shown in Fig 4.1. The main reason of this landslide was due to improper development in the school premises, few years back the school was under development and the channel flowing from behind the school was a big threat to the foundation of the school so the school authorities decided to divert the route of channel. The route change was done by cutting off the trees in the forest behind the school which left the soil loose, as we know the roots of the trees helps in the tightening of the soil and once this was done the channel route got changed and started erosion In the soil which kept on increasing gradually as the years passed and on 9th of July 2023 when the rain was on its peak the soil got failed and debris flow started critically and on the 10th of July early morning this uncertainty took place which completely drowned the fisheries office.

Fig - 4.1 Fisheries Office Shanti Solan

This type of landslide is a classic example of debris flow landslide which mostly happens due to the fast-moving, gravity-driven mixtures of sediment and water with a wide range of grain sizes, often including gravel and boulders, mixed vertically. The occurrence of shallow landslides and debris flows (collectively referred to as ‘debris flows’ hereafter) is significant in the fields of hydro-geomorphology and natural hazard science due to their prominence among natural disasters.

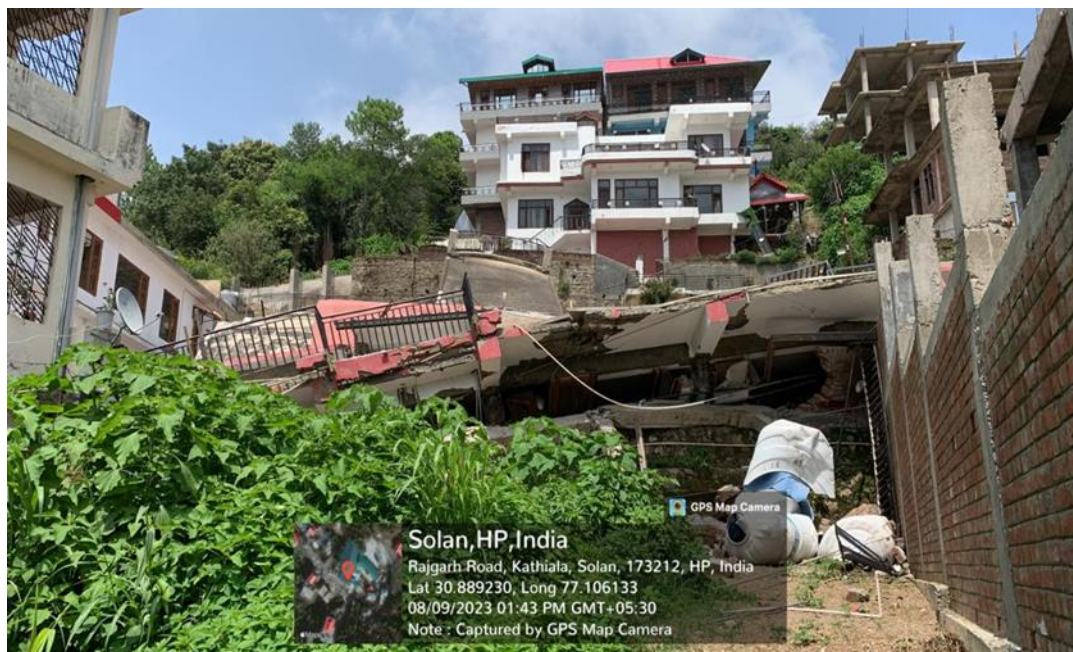
As shown in the figure the building was completely covered from both the sides and the structure also covers a retaining wall blocking its weep holes. As the weep holes of the retaining walls were covered there was no place left for the water to pass and the water started draining in the foundation of the building and the foundation of the building was inappropriate as the SBC of the mentioned structure was not accordingly designed as per the requirements of the building . The water in the foundation got collected resulting in the lateral thrust which finally resulted in pan -cake type of failure in the structure. This type of phenomenon is of particular concern since progressive collapse or pan cake collapse is often disproportionate, i.e. the collapse is out of proportion to the event that triggers it. Thus in structures susceptible to progressive collapse, small event can have catastrophic consequences.

Fig - 4.3 3-Storey Residential Building

(2) A residential building: A 2-storey building which faced pan cake failure as the water broke out in the foundation of building as the weep holes in the retaining walls were blocked with the improper construction.

The major cause of this type of foundation failure is excessive rainfall in this area which was more than the usual rainfall Shamti experiences. Blockage in the weep holes of retaining walls.

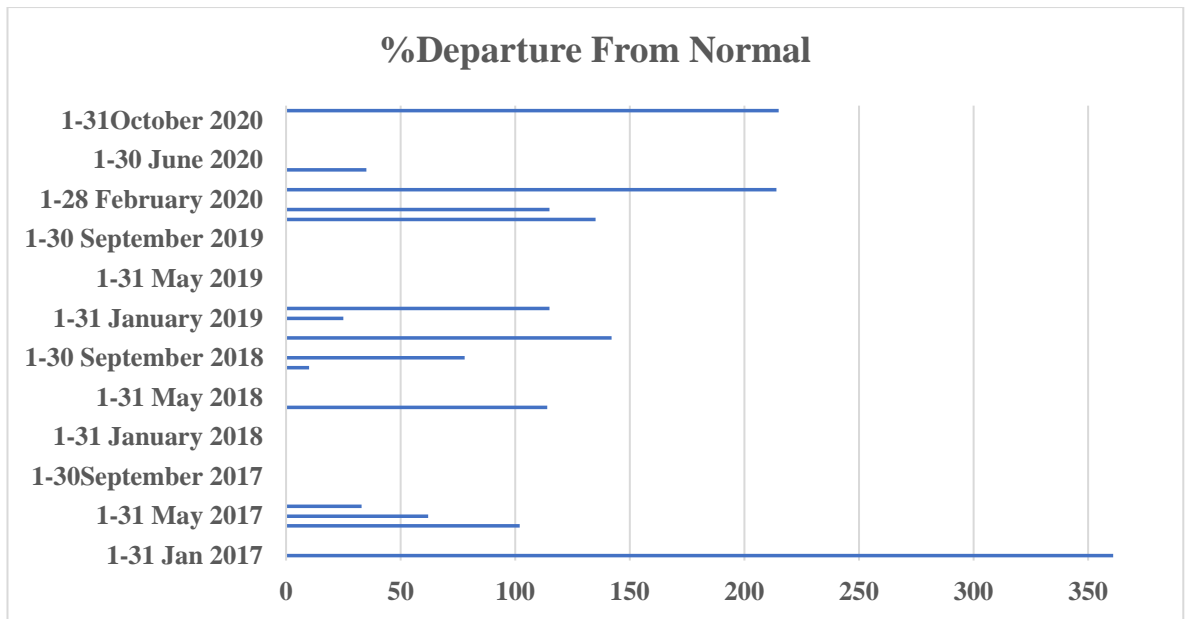
Fig: 4.7 % Departure From Normal

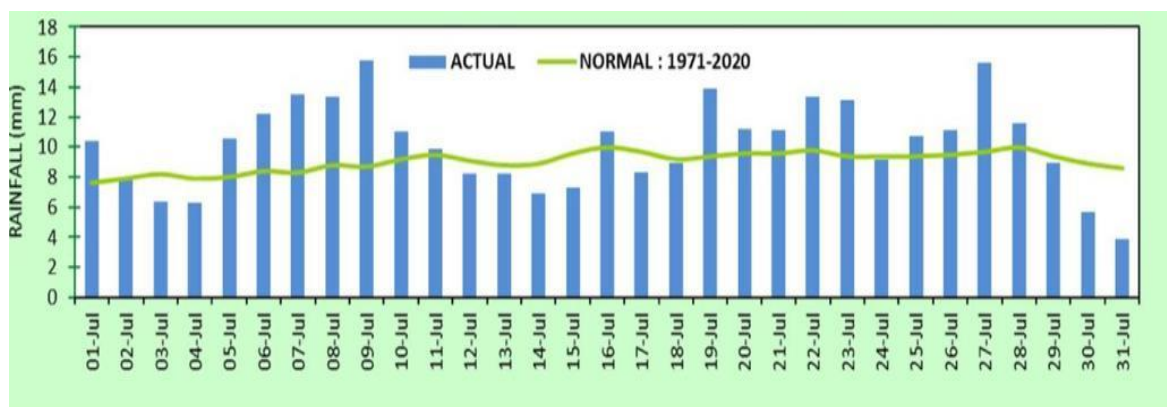
The date of the landslide was July 9, 2023. To comprehend the total precipitation in the Solan area in July, we must examine all past data for the month of July in order to identify the day on which Solan experiences rainfall, which falls between July 7th and July 13th. According to the statistics, the 9th of July is the peak rainfall day for solan.

Fig - 4.8 Graph of the Rainfall in July 2023

The major problem that caused the landslide was the blockage of the water channel from upstream to downstream, which was caused by a flash flood that brought debris with it, causing the blockage in the water channel and resulting in the seepage of water, which eventually started loosening of the soil, causing the landslide.

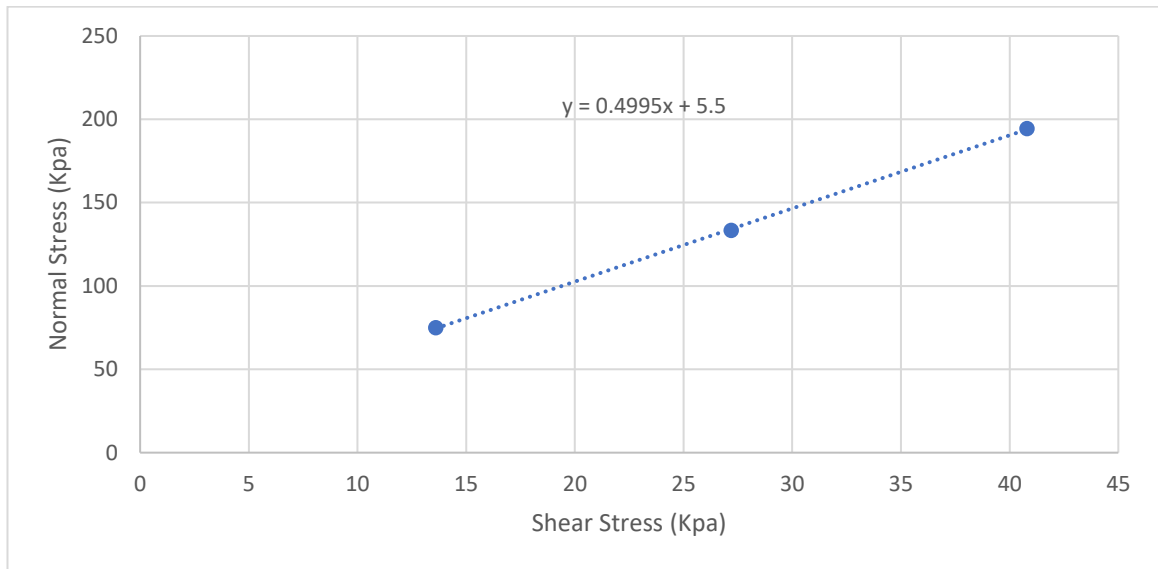
Normal Load (N)	Shear Load(N)	Normal Stress(Kpa)	Shear Stress (Kpa)
4.9	27	50	29.67
9.8	48	100	56.667
14.7	70	200	105

Fig- 5.2 Graph Showing Normal stress / shear stress

$$Y = 0.4995x + 5.5$$

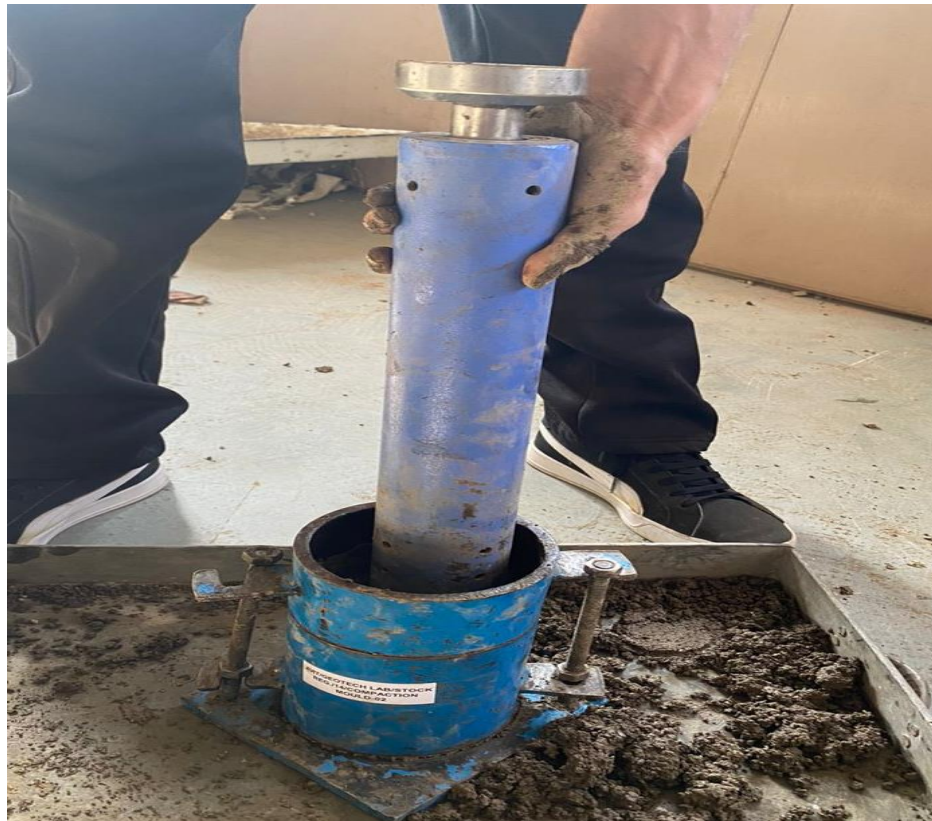
- Approximately three equal-mass layers, each receiving 25 hits from a 2.6 kg
- rammer lowered from a height of 310 mm above the ground.
- The extension must be taken out, and using a straight edge, the compacted dirt must be gently smoothed off to the top of the mould.
- The compacted soil sample has to be taken out of the mould and positioned above the mixing pan.
- It is necessary to weigh the soil and mould.
- Add 2% more water until the dirt and mould start to weigh less.

Fig-5.3 Experimental setup

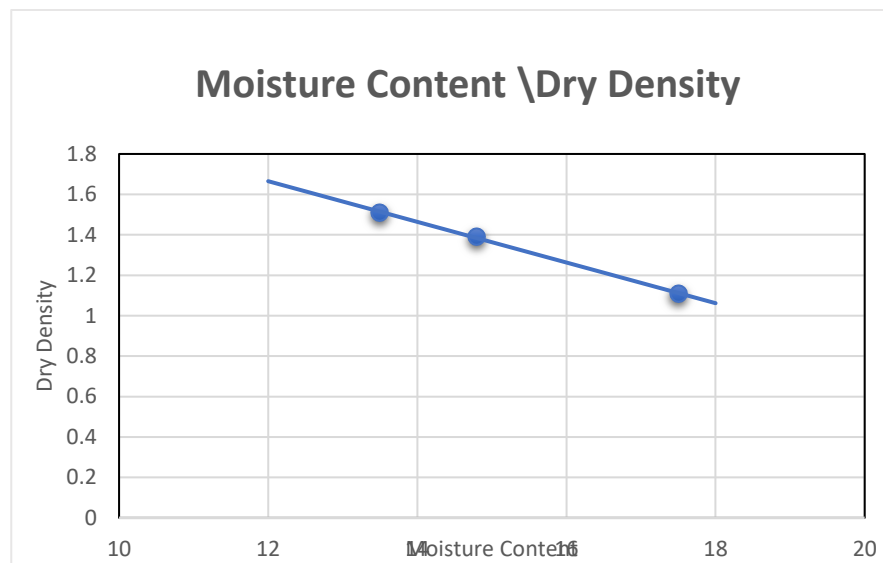
(w ₂) in g			
Weight of container+ dry soil (w ₃) mg	52.4	63.7	61.4
Moisture content w = x100 (%)	13.5	14.8	17.5
Dry density Bulk density (g/ cc) 1 +w	1.51	1.39	1.11

Fig - 5.4 Relation between OMC and Moisture Content

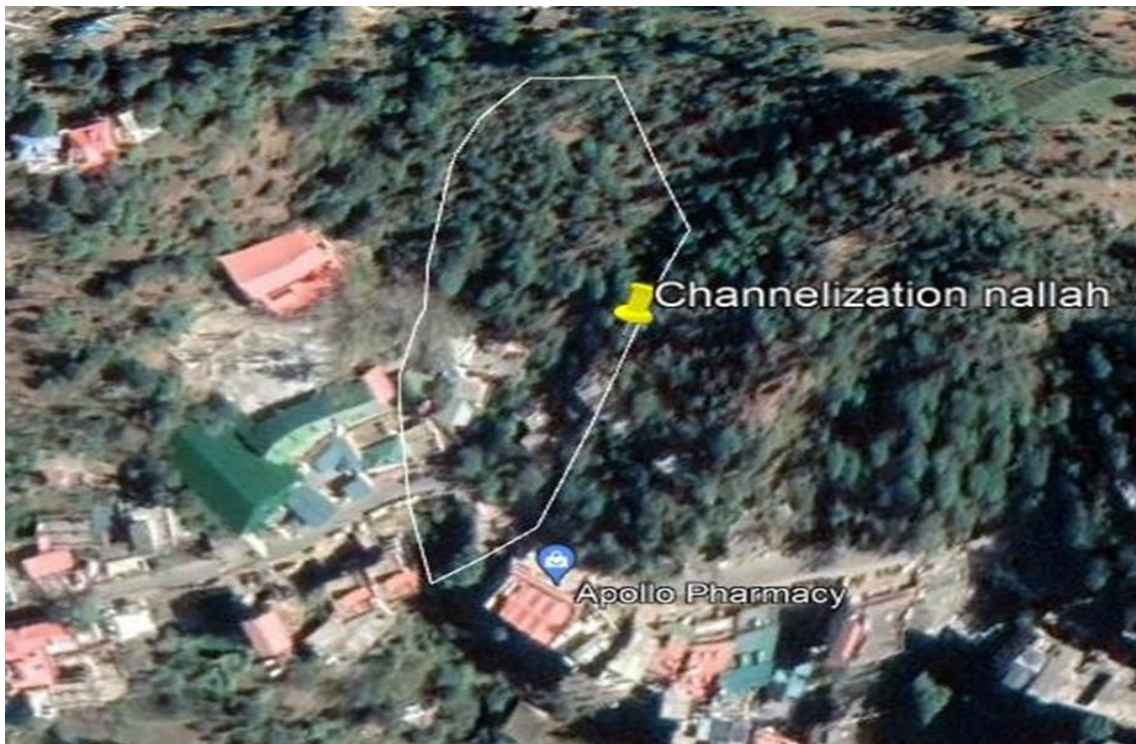
Fig - 6.2 Plan View & Satellite Image of Nala
