**REMEDICATION AND STABILIZATION OF SLOPE IN
RELDRI, BHUTAN**

PROJECT REPORT

CIVIL ENGINEERING

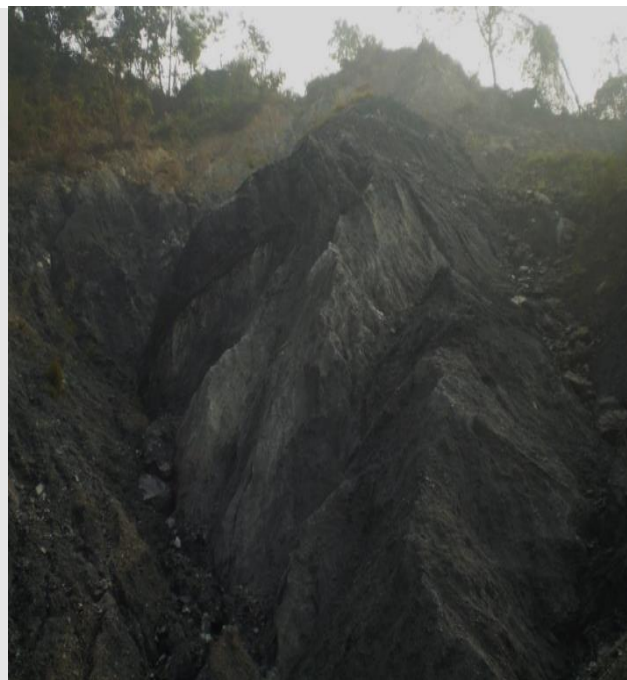
Figure 5 Reldri landslide site

The area experiences a humid tropical climate. The slip plane appears to be shallow but the mass movement is active in the process. Three types of soil in the study area were colluvial, fluvial and residual soil. Seepage of the water is most common in this landslide area and there is no growth of vegetation particularly in the active landslide area. Location of landslide as shown in figure 4 and 5.

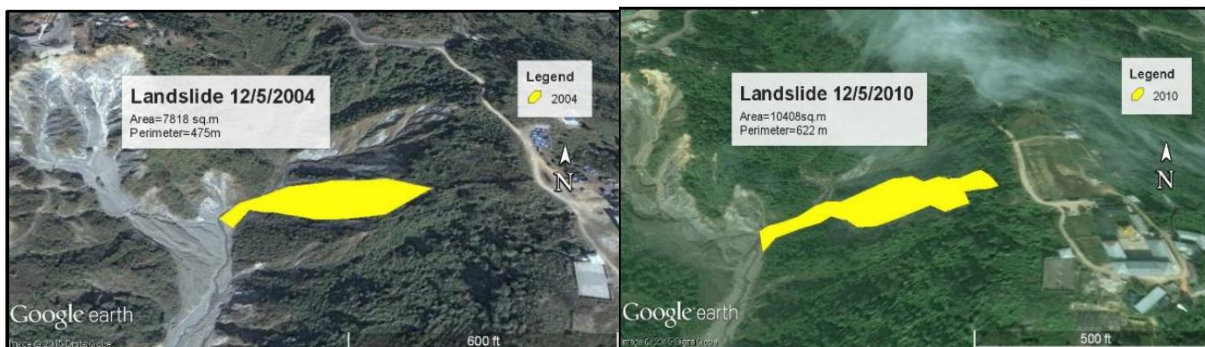
Figure 6 Satellite image of 2004

The slope at Reldri region, started with the development of small-scale erosion from the small stream below the landslide area. Bhutan's NAPA-II project report revealed that the active erosion has been developing in the area since 2000. According to the Proprietor in-charge of Reldri Higher Secondary School, the landslide had started to occur in 2000 but the land degradation became clearly visible only since 2004 as given below in figure 6.

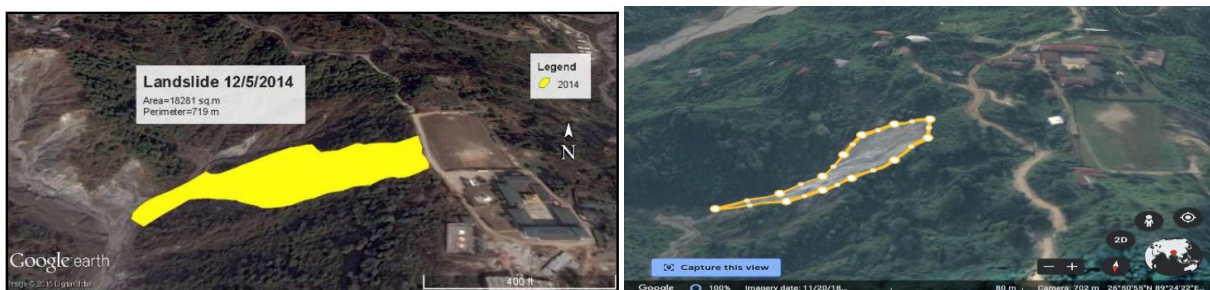
Figure 8 Satellite image of 2014

Google image is one of the important sources for tracing the historical information. However, the information is available only since 2004 and it was noticed that landslide has been in the stages of expansion over the times. A series of historical satellite images from Google earth since 2004 had to be examined to see the changes of areal expansion in Reldri shown below in the figure 7, 8 and 9.

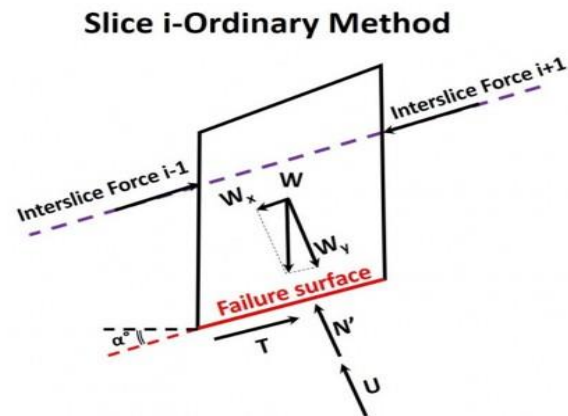
Figure 16 Based on the Ordinary Method of Slices, the forces acting on a typical slice. The interslice forces are assumed to be collinear and are therefore ignored.

Fellenius (1936) developed the Ordinary Methods of slices. This is the most basic method of slicing. It is the only method that yields a linear factor of safety equation. The slip surface is thought-out to be circular and the mass of soil is distributed into a number of slices; vertical. In this method the inter-slice forces are ignored, because they run parallel to the bottom of each slice.

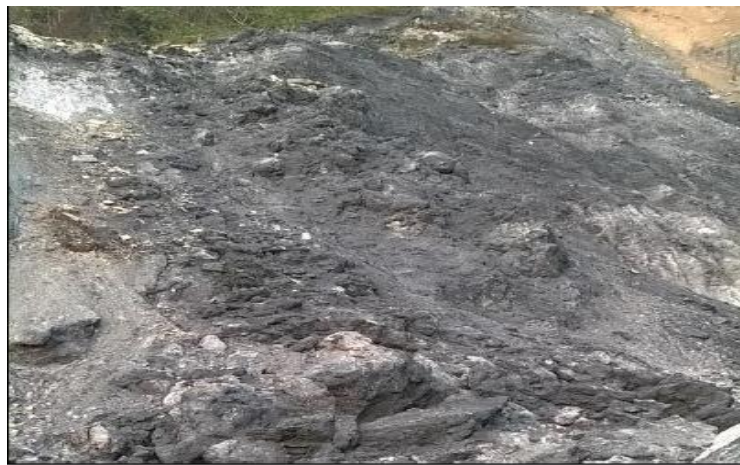
Figure 21 Mudflow

Reldri slope can be classified as mudflow. It had been found that the soil samples of the Reldri slope consisted of more than 50 percent by weight of particles of both sand and silt. Hence it could be concluded that the particles in the slope can be classified as mudflow.

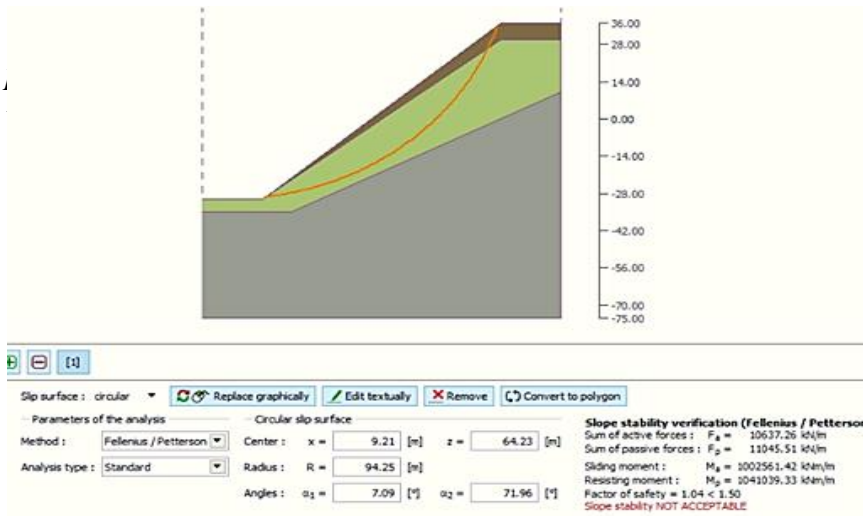
Figure 25 Factor of safety computed in Geo5 by Fellenius Method

The Factor of safety came out to be 1.04 and it is less than maximum acceptable factor of safety as shown in figure 25.

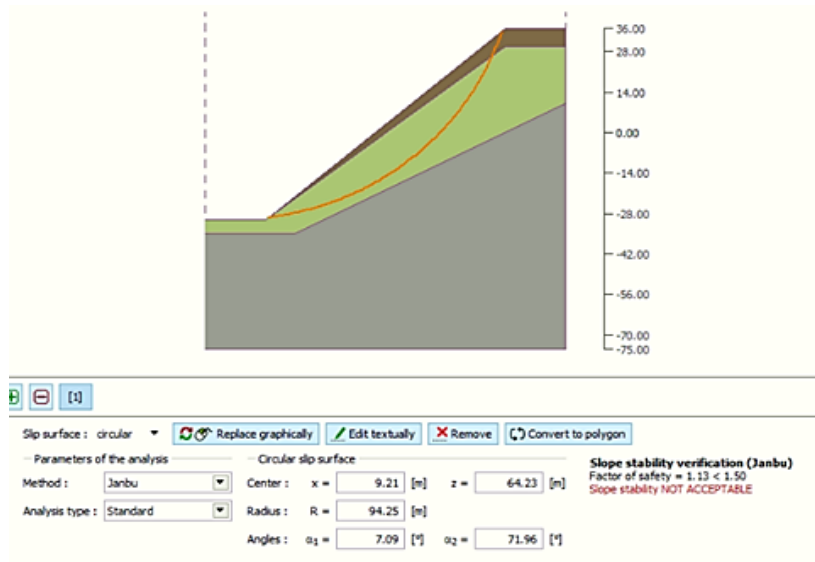
Figure 27 Factor of safety computed in Geo5 by Janbu Method

The factor of safety came out to be 1.13. i.e., less than 1.50 and the slope stability is not acceptable as shown in figure 27.

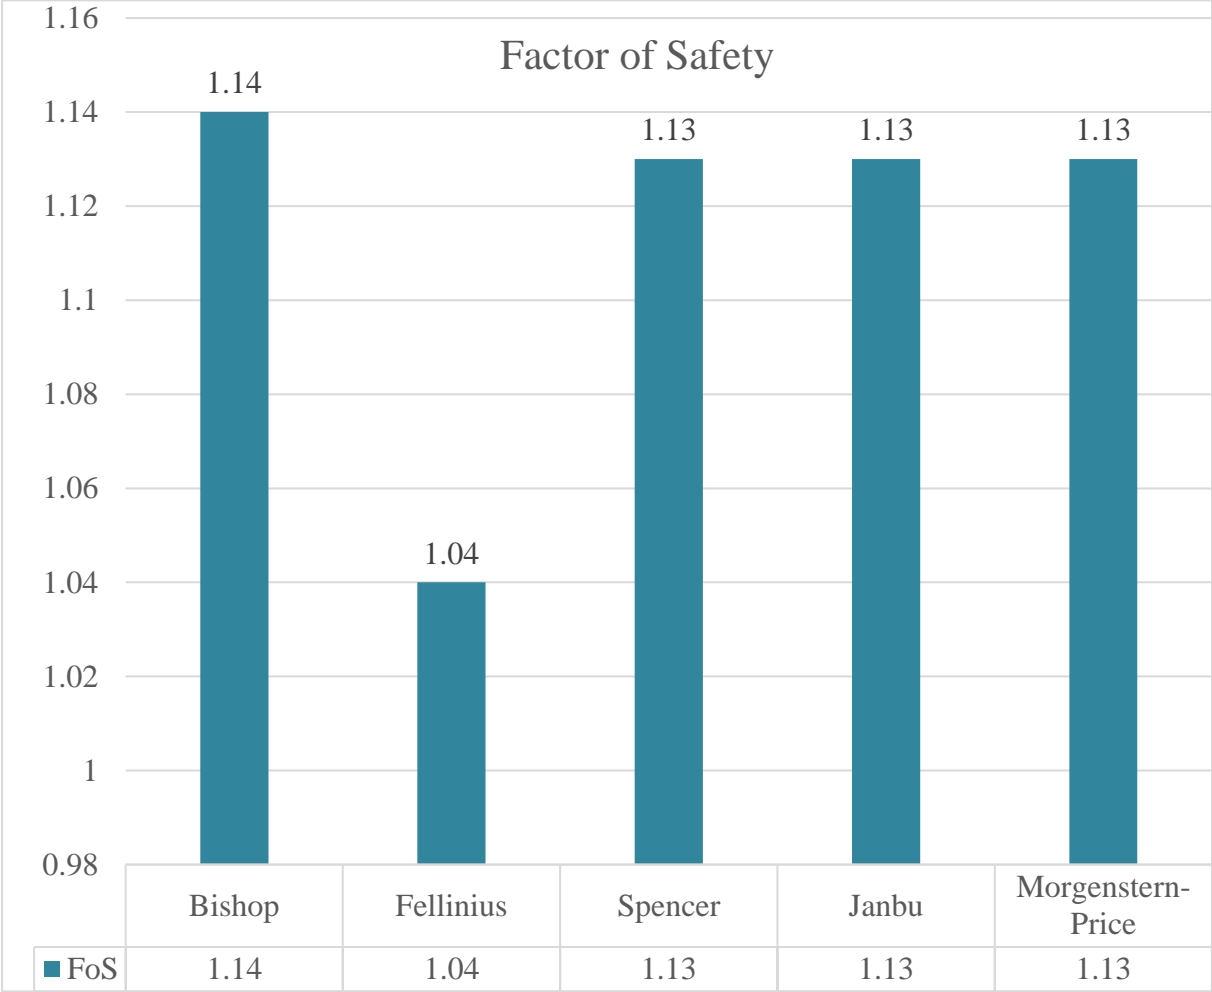
This graph shows the different values of factor of safety got from the GEO5 software by 5 types of methods.

Figure 29 Graph plotted between factor of safety and various limit equilibrium methods

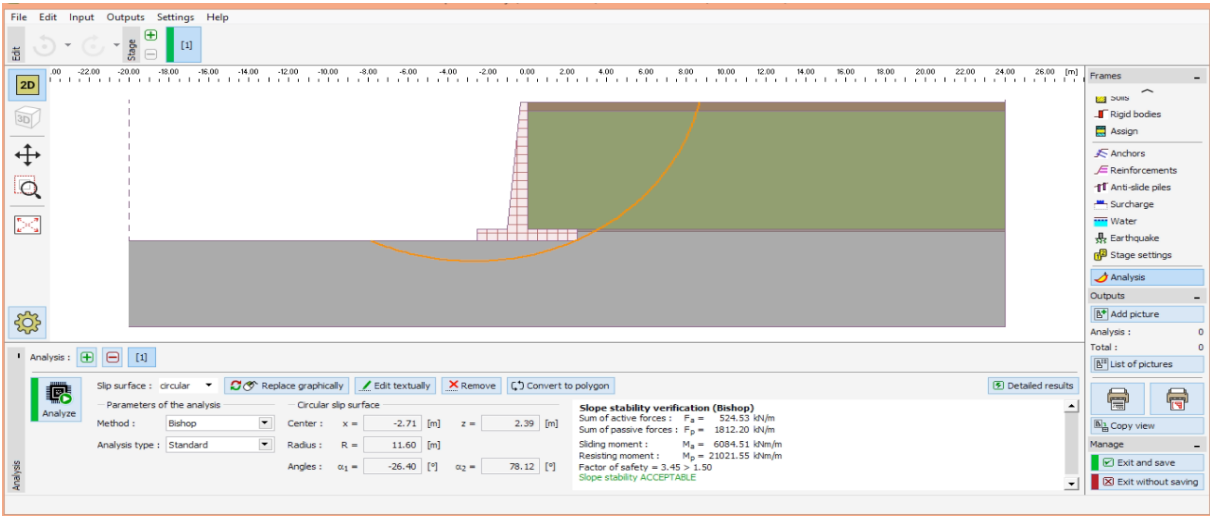
Figure 40 Factor of safety by Bishop method

After the dimensions of the retaining wall were inputted into the software, we ran the analysis to analyze the stability of the slope with retaining wall as the mitigation measure. The results were obtained from all the limit equilibrium methods.

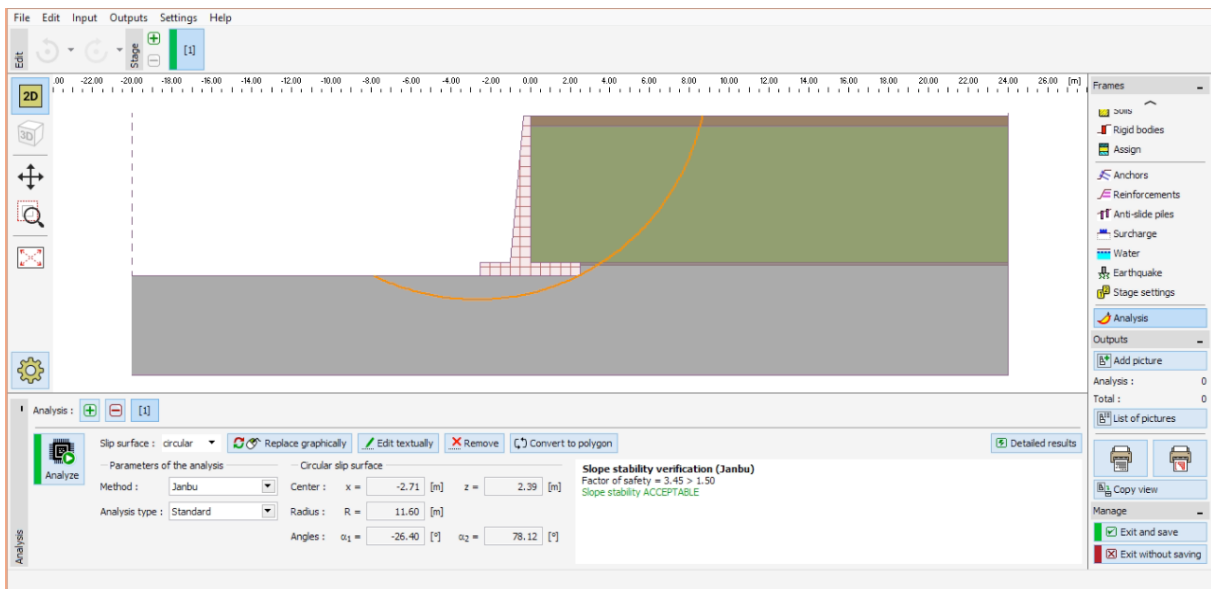
Figure 42 Factor of safety by Janbu method

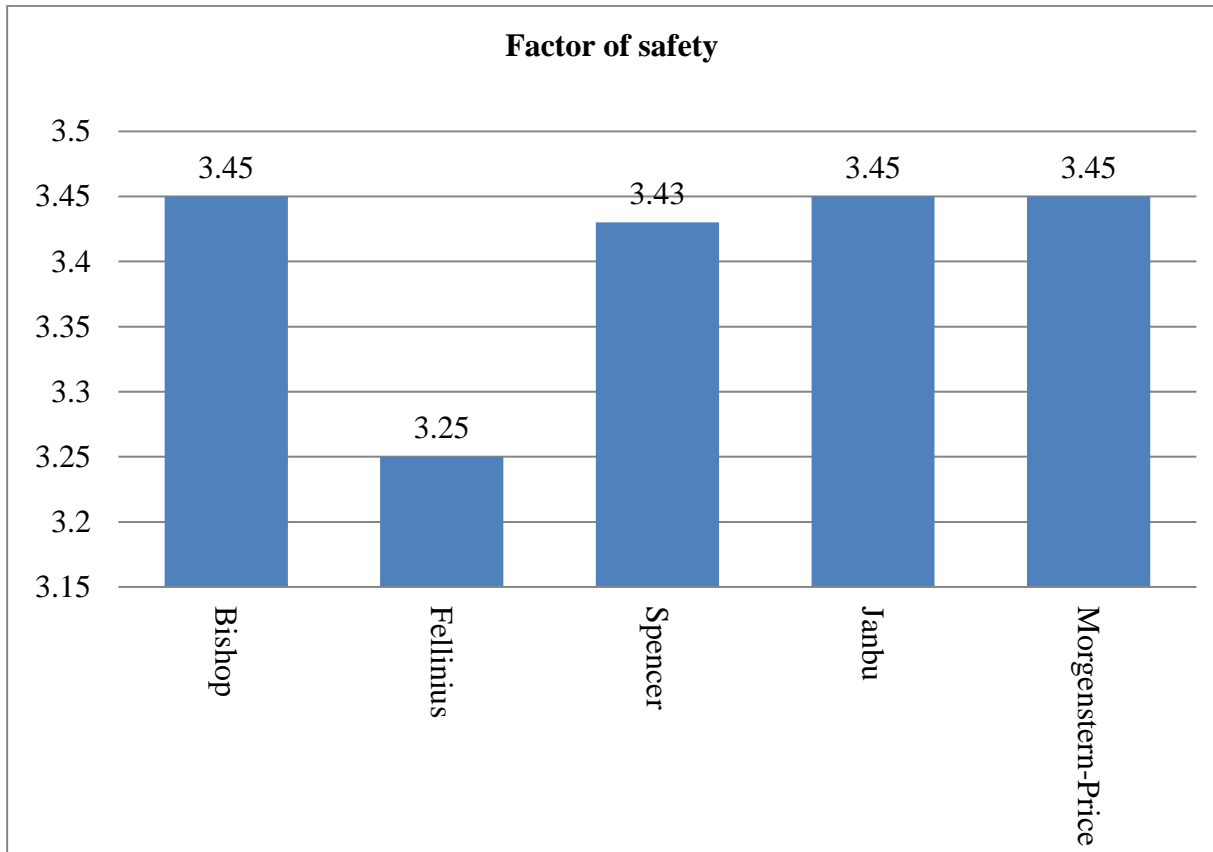
Figure 45 Factor of safety after giving retaining wall

The graph given above shows the analysis of factor of safety after giving retaining wall where the slope came out to be stable under all conditions.
