**REPAIR TECHNIQUES AND REMEDIES FOR STRUCTURAL FLAWS
FAILURE IN JUIT**

Project Report submitted in partial fulfillment of the requirement for the degree of

Civil Engineering

DEFECT IN REPAIR WORK ON THE ROOF OF ECE DEPARTMENT

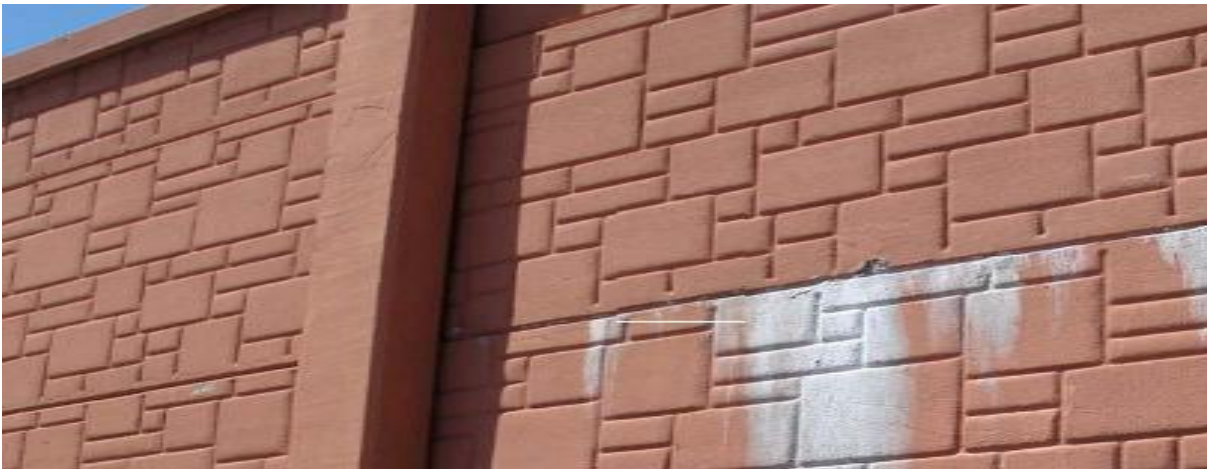
- **Lime Boom:** It appears as white patches on an overall lining of the surface of concrete. This is a construction problem.

Fig 1.3 Lime boom efflorescence

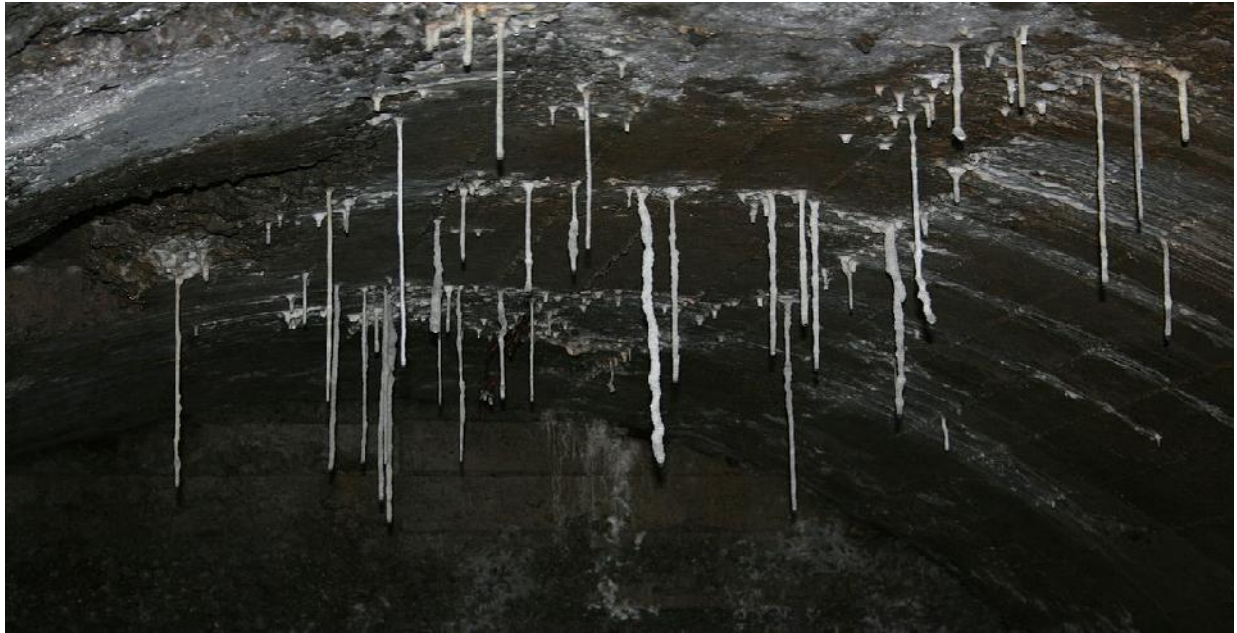
Fig 14 Lime weep efflorescence

- **Lime Weeping:** it is caused by water leaking through the concrete and dissolving calcium hydroxide from the matrix. On contact with the atmosphere the calcium hydroxide reacts with carbon dioxide to form calcium carbonate, which is precipitated on the surface when water evaporates. Generally at the cracks or joints, serious leakage may be symptomatic of a more severe problem and can lead to durability problems.

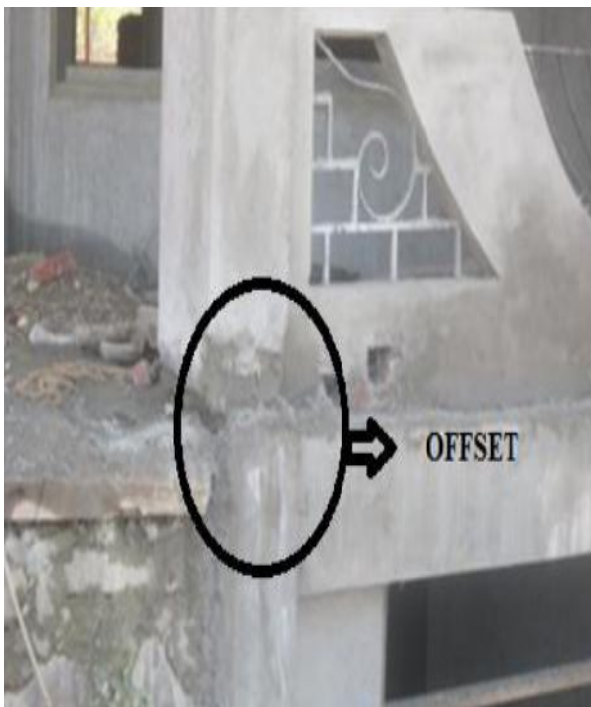
Fig 3.4 Column Offset.

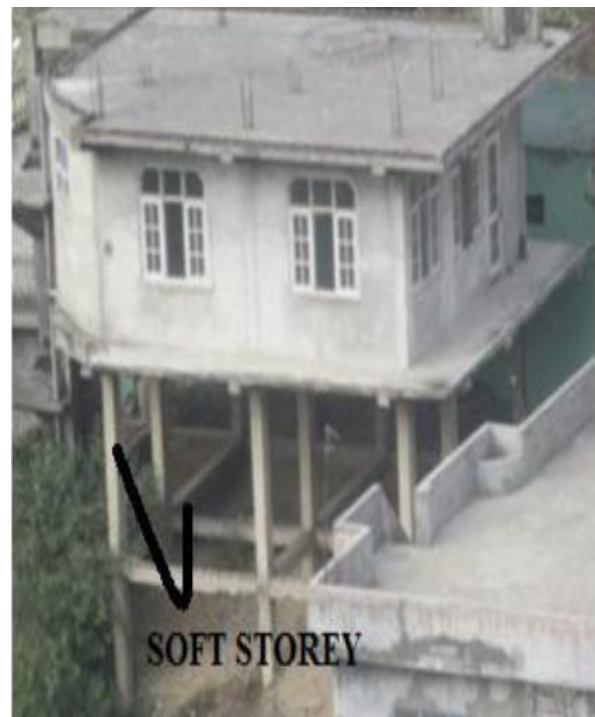
Fig 3.5 Soft Storey.

A soft storey is one in which the lateral stiffness is less than 70% of that in the storey immediately above, or less than 80% of the combined stiffness of the three stories above. The essential characteristic of a weak storey consists of a discontinuity of stiffness, which occurs at the second storey connections. This is caused by lesser strength or increased flexibility and also the structure results in excessive deformations in the first storey of the structure, which in turn results in concentration of forces at the second storey level. These stories are more likely to get collapsed or were severely damaged during earthquake. Many buildings with an open ground storey (soft storey) were observed in Kandaghat. Fig. 3.4.2 shows a residential house being constructed and the ground and first floor are left empty whereas a house is dwelled in second storey. Fig. 3 and Fig. 4 are also good examples of soft storey. This defect can be minimized by constructing shear walls at the ground level so as to eliminate the discontinuity in the lateral load resistance path and to increase stiffness of soft storey .making it comparable with other.

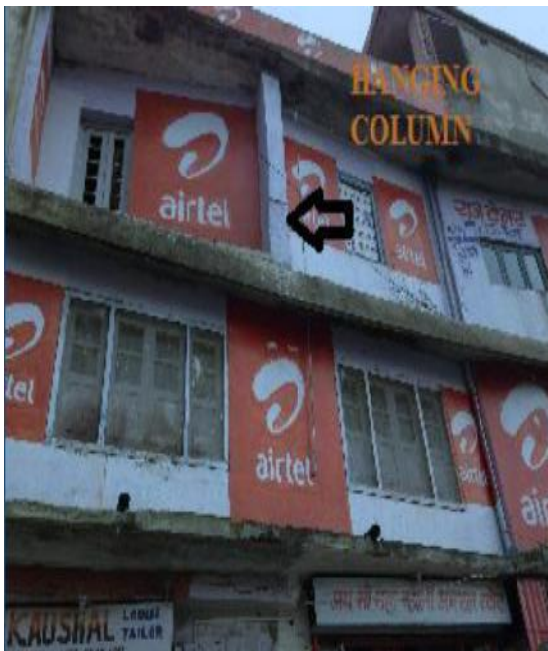
Buildings with columns that hang or float on beams at an intermediate storey and do not go all the way to the foundation, have discontinuities in the load transfer Path. It may lead to catastrophic failure of buildings. The buildings shown in Fig.3.4.4 and Fig. 3.4.5 are located in the main market of Kandaghat. Fig. 3.4.4 is a residential building where people dwell in first and second storey and ground storey is used as shopping area. This building has hanging column whose load is going nowhere but borne by beams only. Fig. 3.4.4 clearly show that the column do not continue up to the foundation but rather end at an upper level. Due to this, Shear is induced to overturning forces to another resisting element of a lower level. Thus, site Engineer must be aware of the fact that load transfer path should be continuous. All the columns and walls must extend to the foundation in order to mitigate horizontal ground motions. Fig. 3.4.5 also shows a residential building with a numbers of hanging, long and short columns (discussed in coming text). There must not be any floating columns in buildings.

Fig 3.7 Hanging columns or floating columns

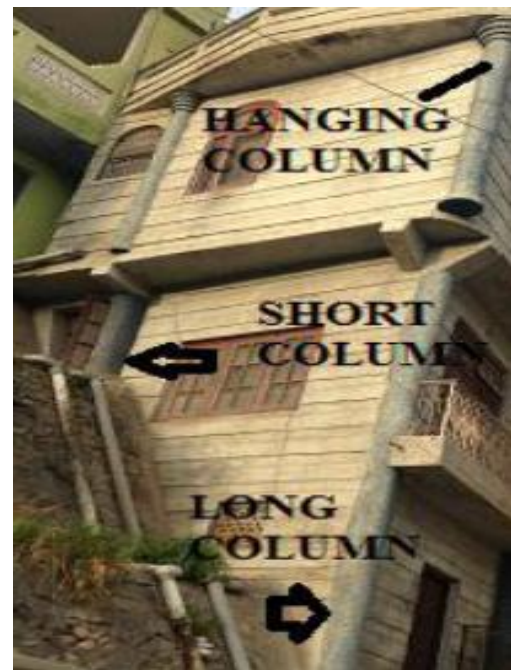
Fig 3.8 floating columns or short columns
